Arkema Facility - Harvey Response

Crosby, TX

September 4, 2017

Project #109489 Summary

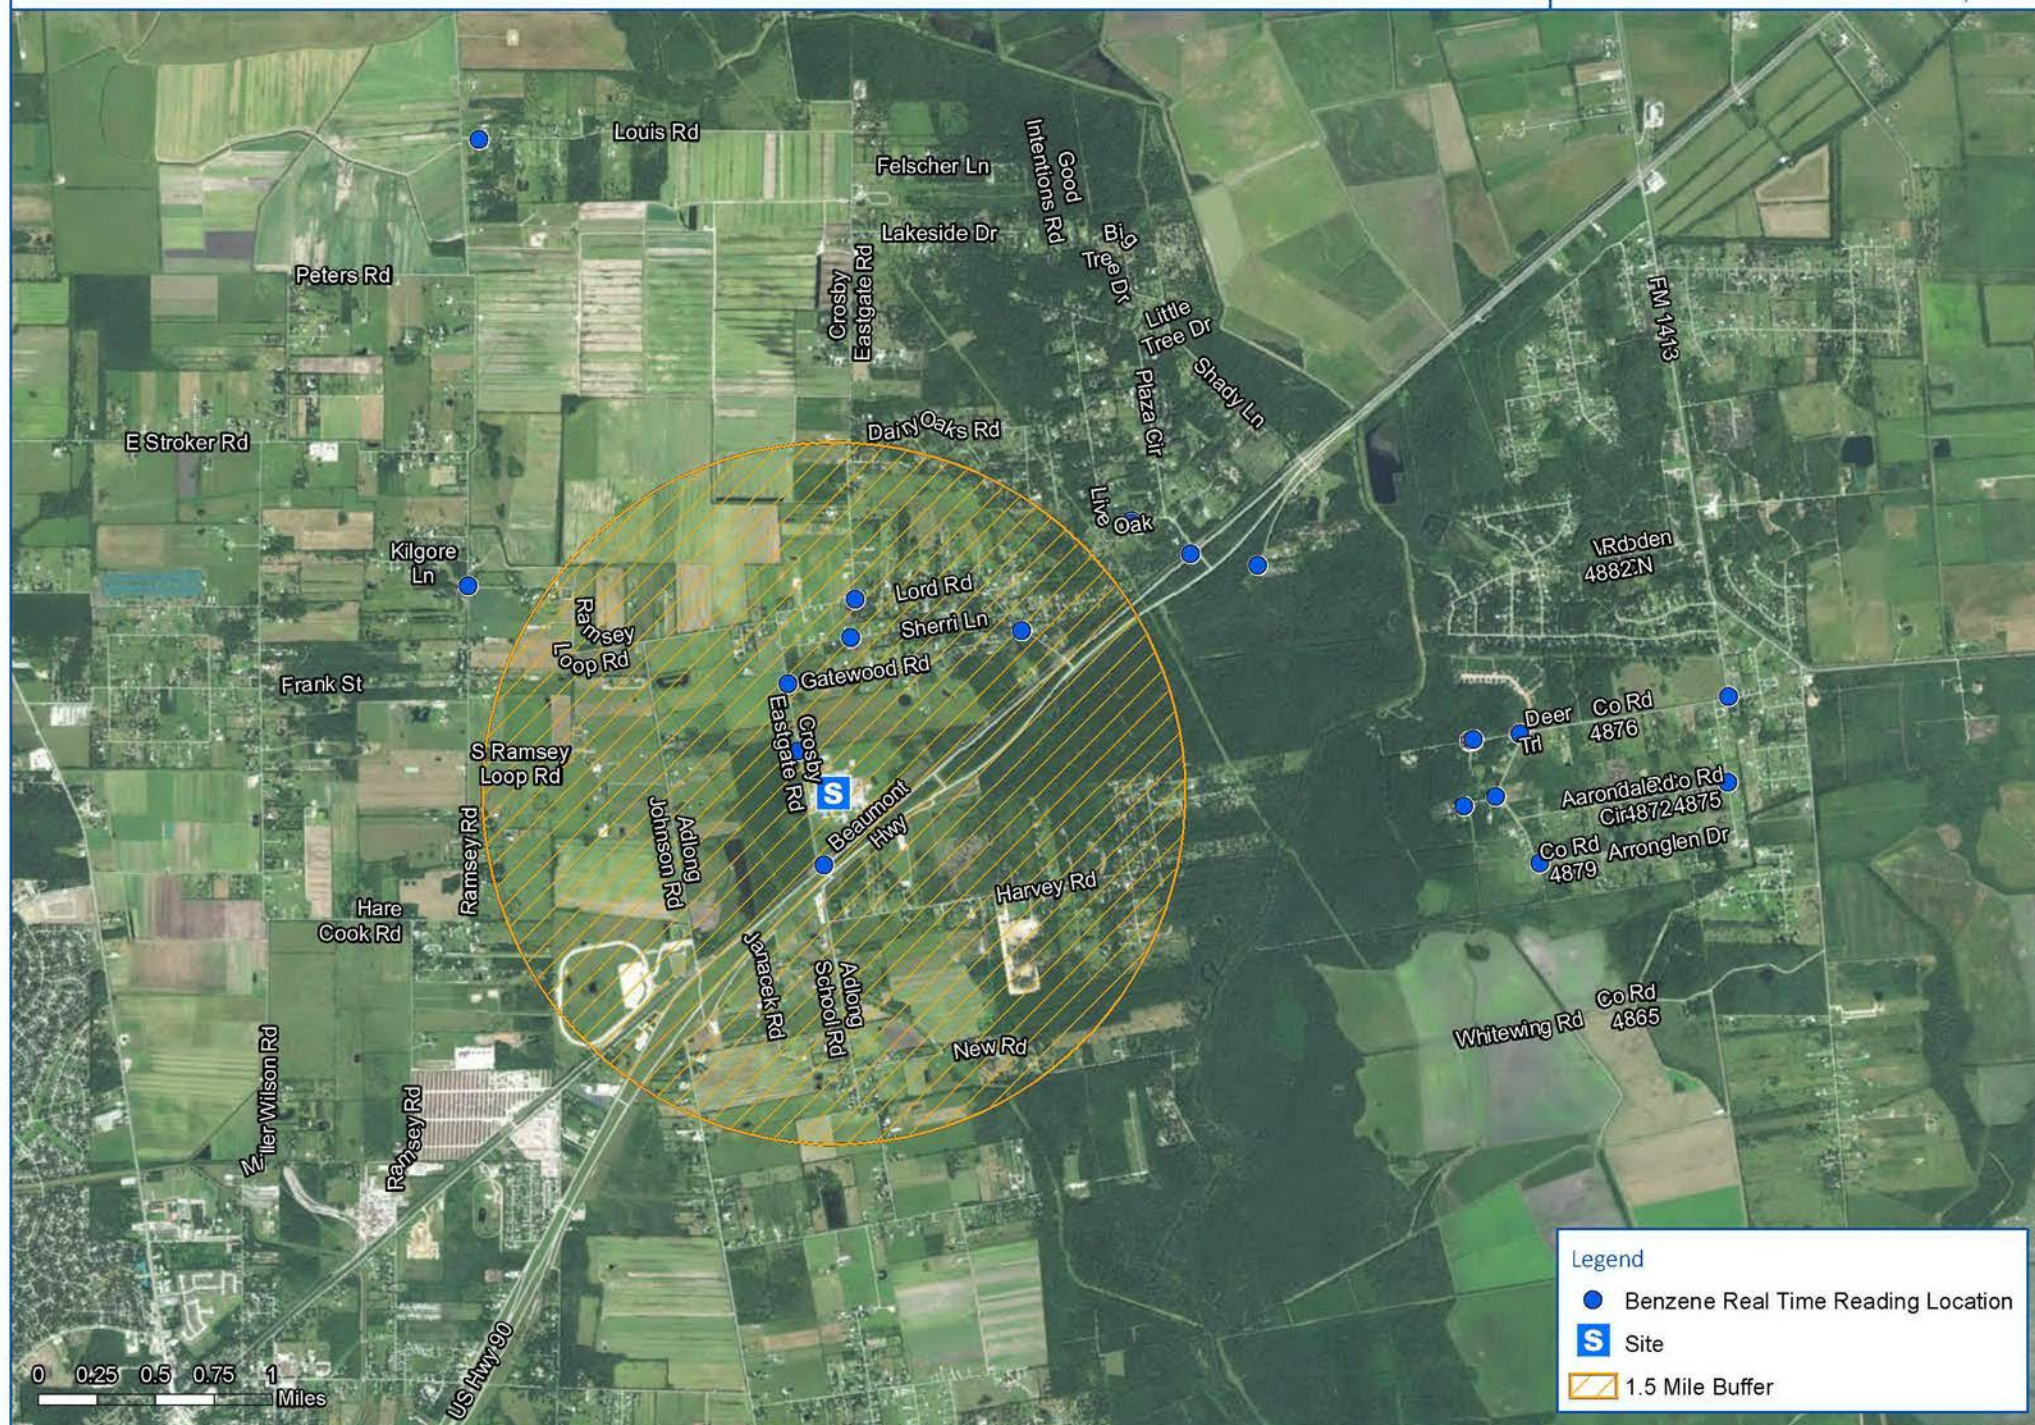
Attachment B

All real-time air monitoring instrumentation was calibrated per the manufacturer's recommendations prior to air monitoring. Handheld, real-time air monitoring was conducted for benzene and volatile organic compounds (VOCs) using RAE Systems UltraRAE and MultiRAE instruments. Additionally, combustion byproducts potentially associated with fire smoke, such as particulate matter (PM_{2.5}), nitrogen dioxide (NO₂), and sulfur dioxide (SO₂) were assessed using Gastec Tubes, DustTraks, and AM510s. **Table 1** summarizes the data for all real-time air monitoring readings recorded in Crosby, TX from 06:00 on September 3, 2017 through 06:00 on September 4, 2017. Maps of real-time air monitoring locations are provided as **Attachment B**.

Handheld Real-time Air Monitoring Locations

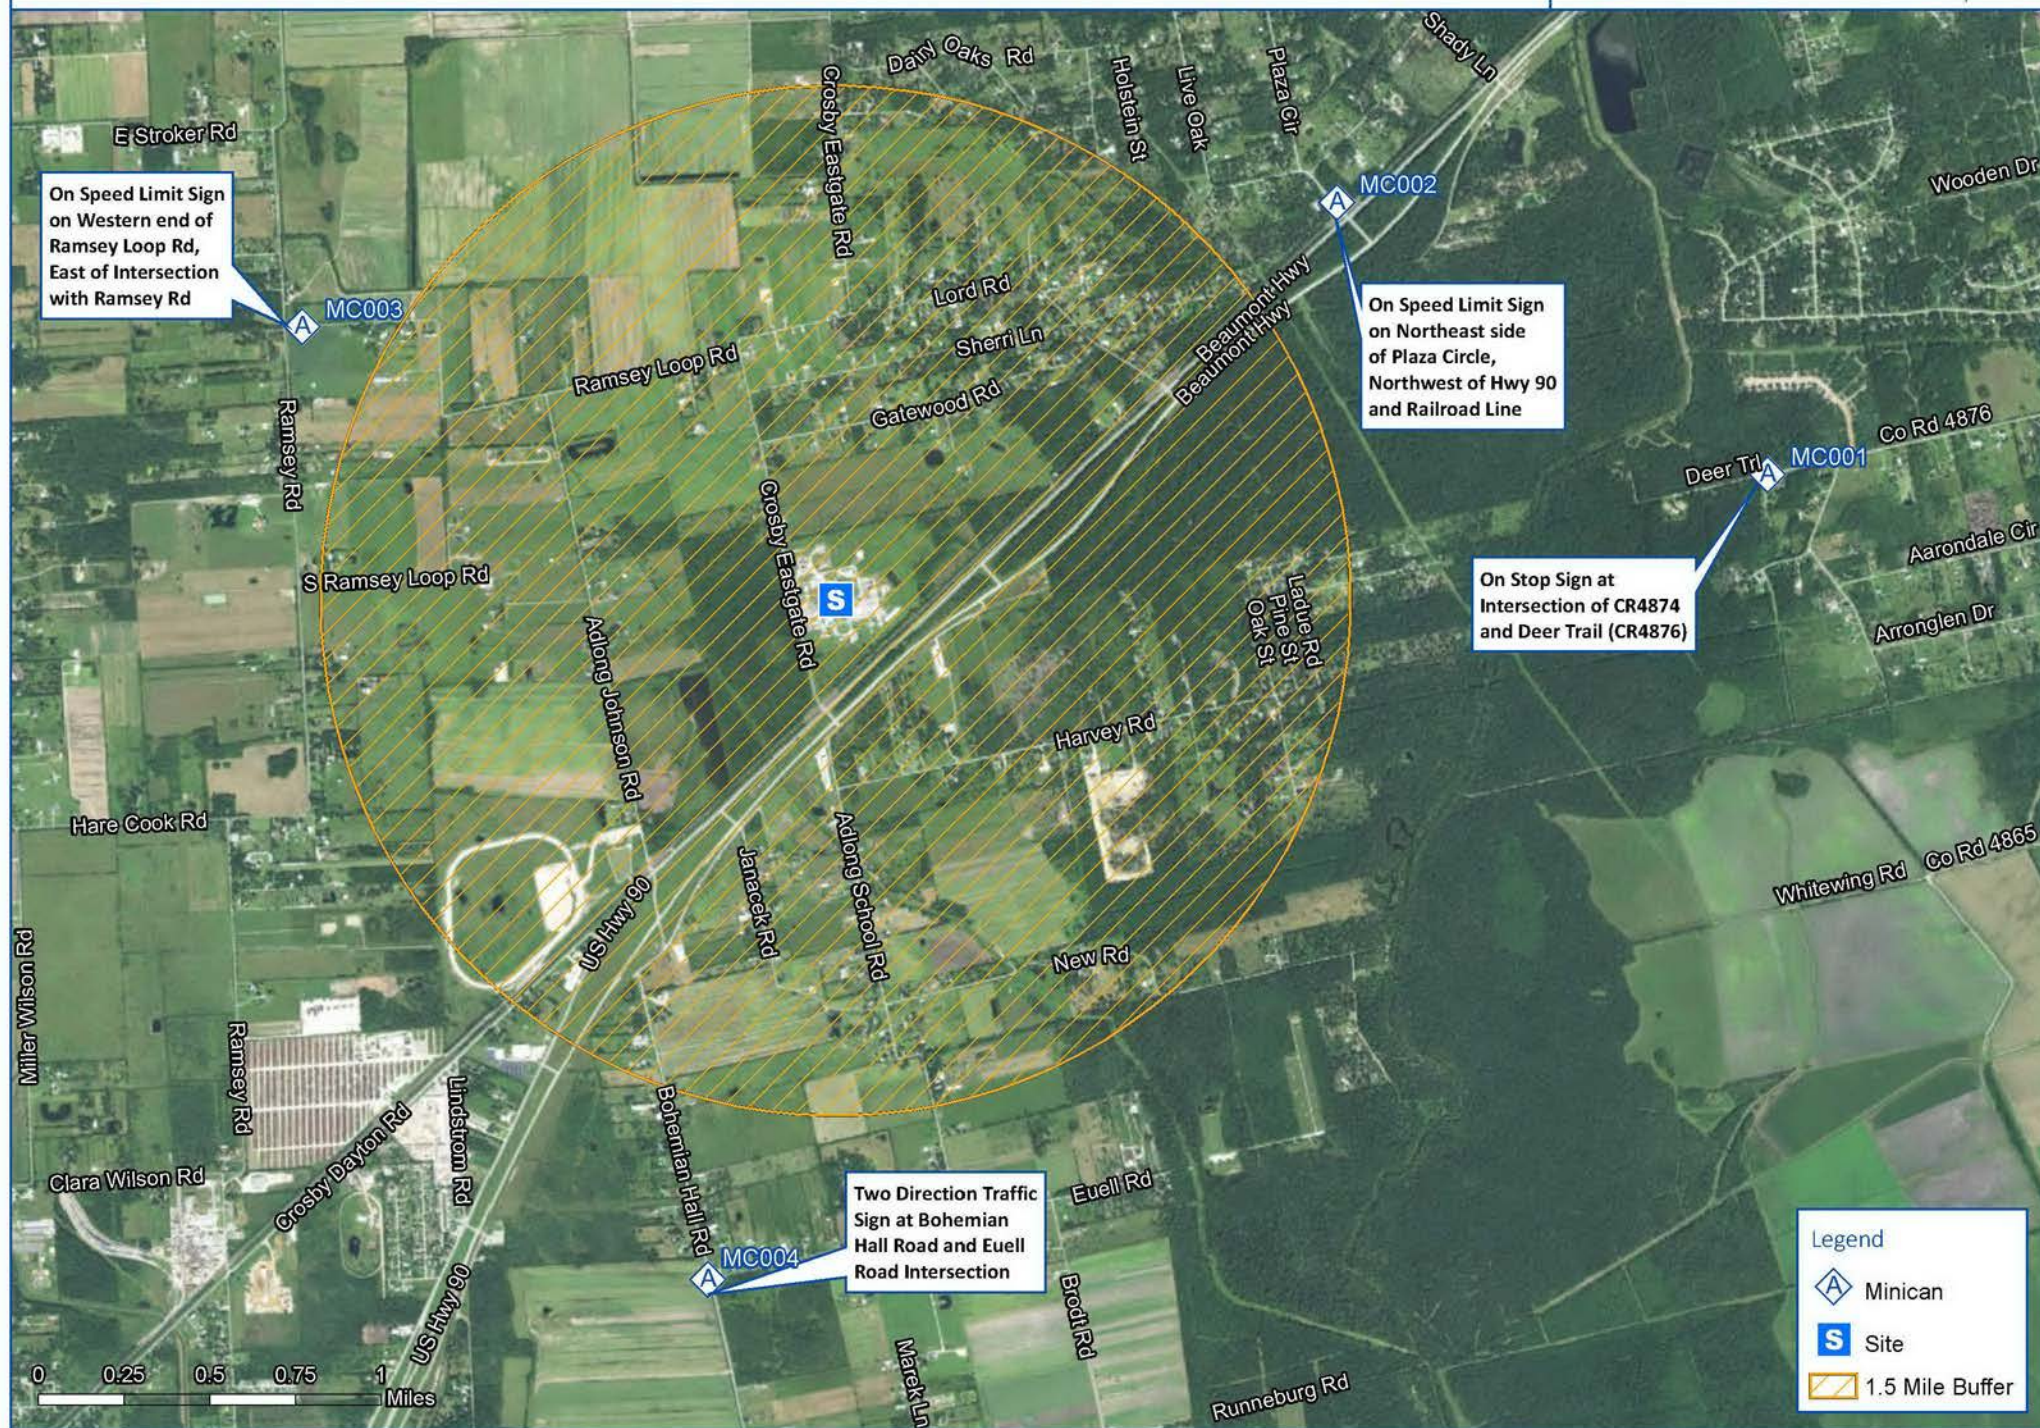
Attachment C

To supplement real-time air monitoring, CTEH® deployed areas along the perimeter of the evacuated area within the community. Evacuated canister (Minican™) samplers were regulated to collect air evenly over a 24-hr period. Analytical air samples will be submitted to SGS Galson Laboratories, an AIHA-accredited laboratory, for analysis using EPA Method TO-15. A map highlighting the analytical air sampling locations is provided as **Attachment C**. Analytical Air Sampling Results will be reported upon receipt from the laboratory.

Map of Analytical Air Sampling Locations

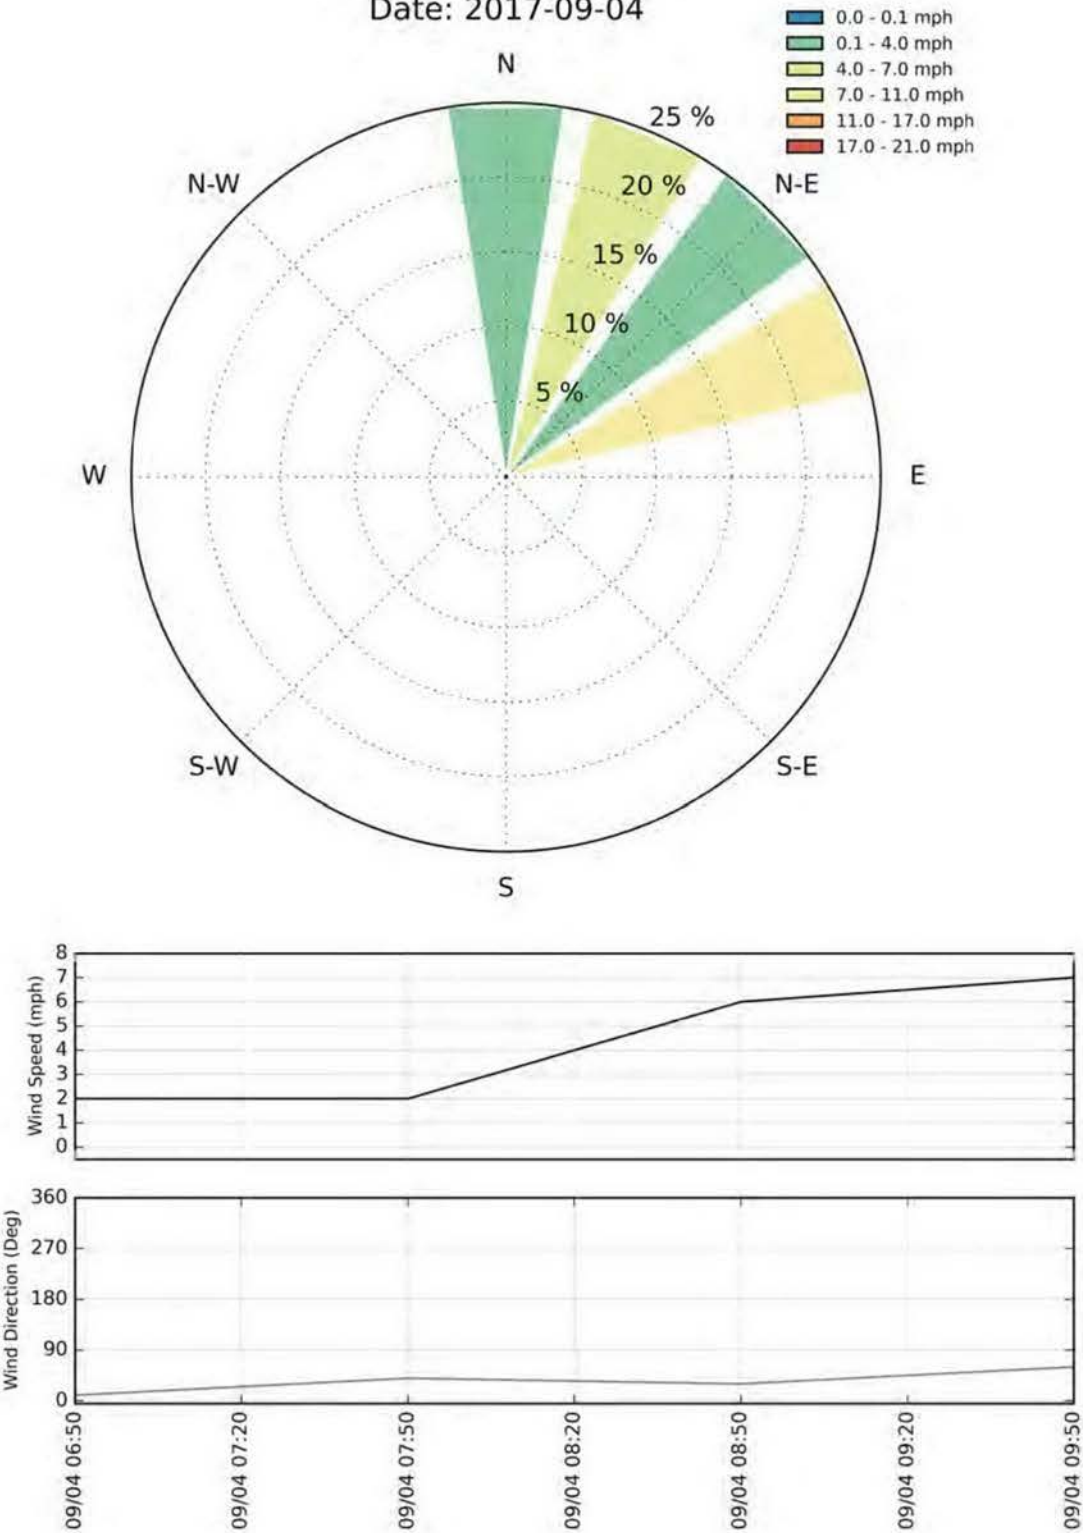
Weather Station: KHPY
Date: 2017-09-04
